3809 REPORT OF INSPECTION

Date: May 14, 2001 Time: about 12:15pm Location: T.5S. R.24E. Sec 6 S2 of Lot 8

Serial no. of notice: UTU 66357 (Hiko Bell project area) Is the operation active? No

Attachment to May 14, 2001 inspection of Hiko Bell project area (UTU66358).

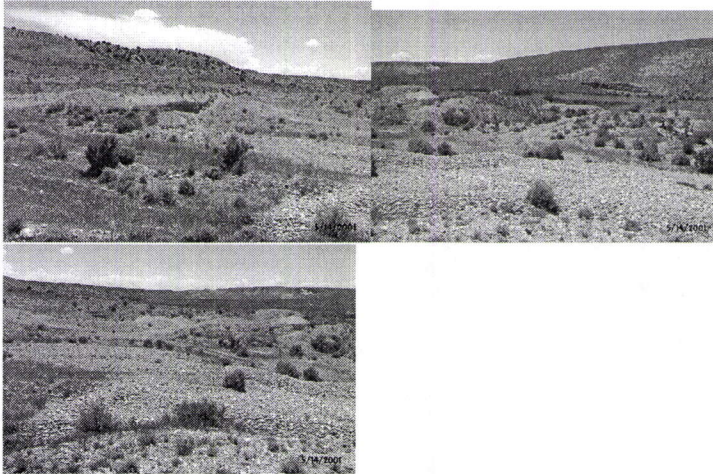
image 1 - view to SSE (left) to SW (right) from about 100' north of the project area (highwall at left is eastern side of project area)

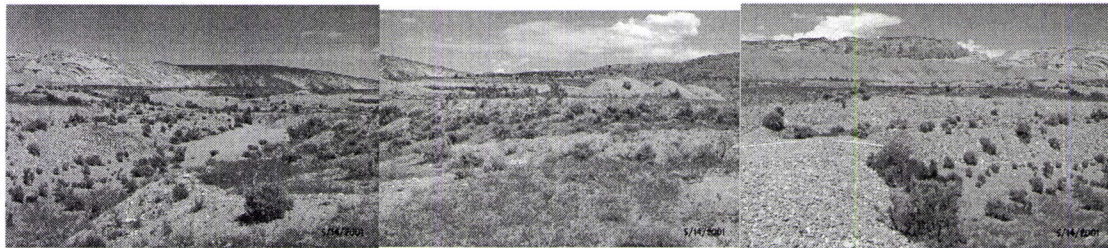
image 2 - view to NNW (left) to NE (right) from southern part of project area (dried settling pond lower left to center), cut (as in image 2 of 10/23/2000 I&E) is at center left and highwall is at right.

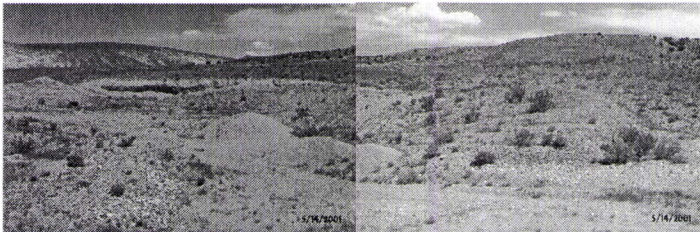
image 3 - view to north (left) to ENE (right) from southeastern part of project area (note highwall at center, stockpiled topsoil at right, eastern part of dried settling pond at left-center, seen in center of image 2)
